Intel® Xeon™ Processor with 800 MHz System Bus Specification Update

June 2004

Document Number: 302402-001

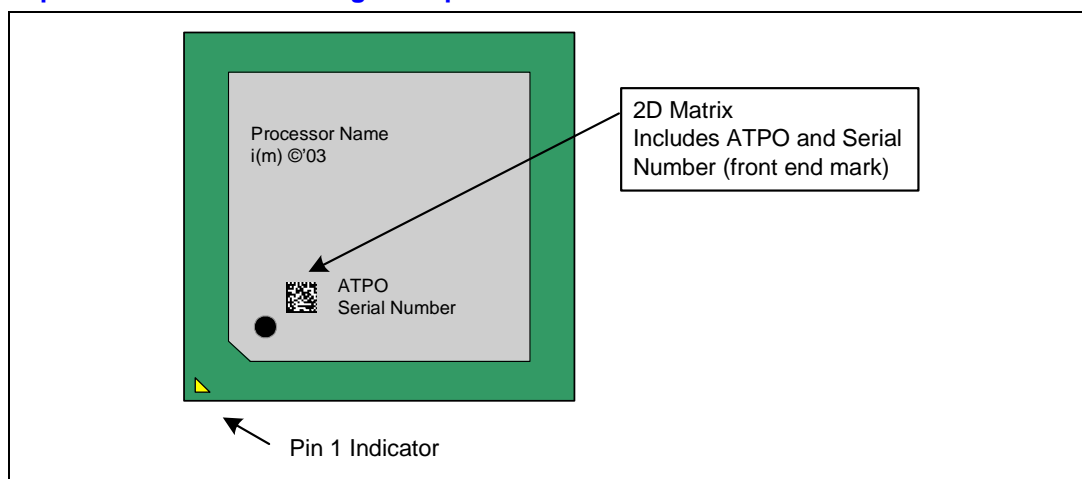
Figure 1. Top Side Processor Marking Example

Intel® Xeon™ Processor with 800 MHz System Bus Package Markings (604-pin FC-mPGA4 Package)
